Manhole Inspection Summary

Manhole # S23AA1006MH

Location Address: **3633 BUENA VISTA AVE**

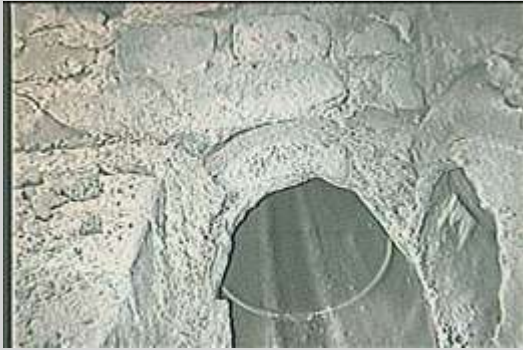
8 in. Circular Gravity Sewer

Pipe Material: **Clay** ☐ Pipe Lined

Invert Depth: **8.71** (ft.) Flow Characteristics: **Slow**

Infiltration: **None** Pipe Seal Cond: **Unknown**

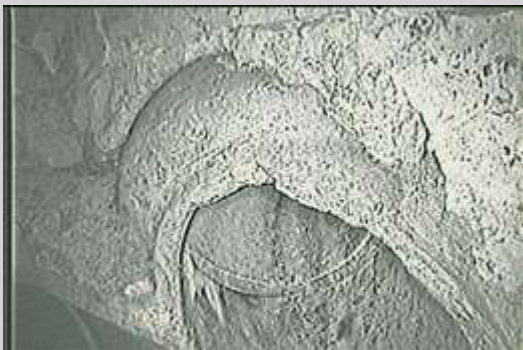
6 in. Circular Gravity Sewer

Pipe Material: **Clay** ☐ Pipe Lined

Infiltration: **None** Pipe Seal Cond: **Unknown**
